DDAS Accident Report

Board of Inquiry Report

[Demining group], Libya (Daphniya)
Fatal Accident - 03 March 2012

Report date: 12 March 2012

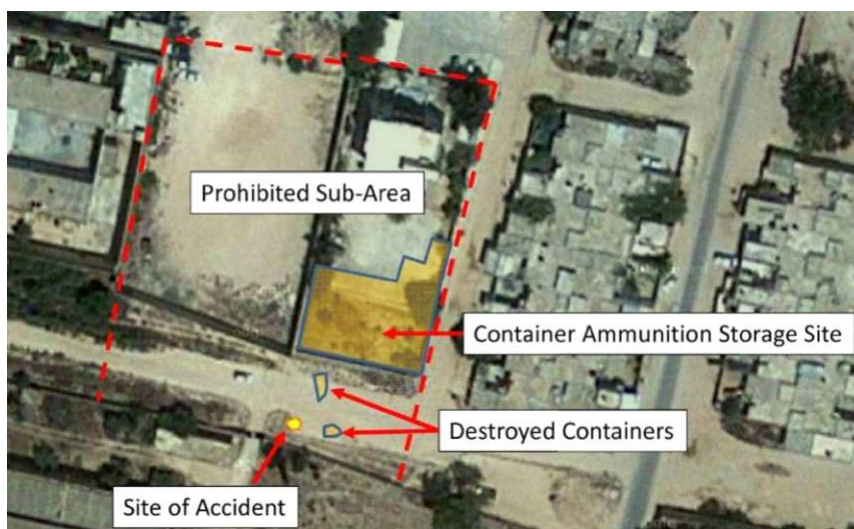
Image 3: Prohibited Sub-Area Overview

The overview below (Image 3) is a close up image of the prohibited sub-area showing key locations.

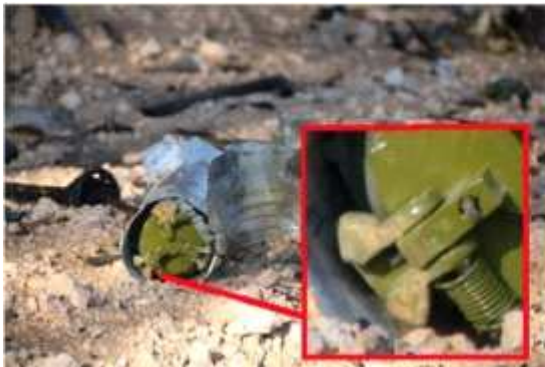
Armed Type 84 mine, still in the broken carrier.
condition.

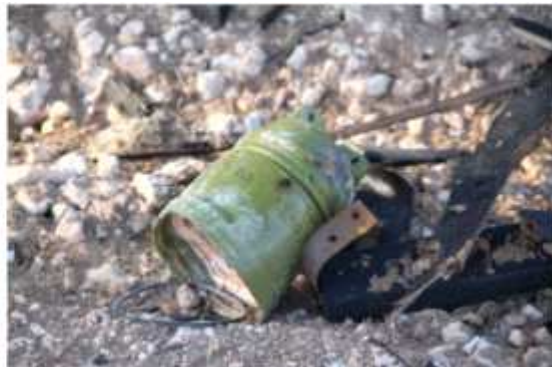
Type 84 mine in unknown, but possibly armed,

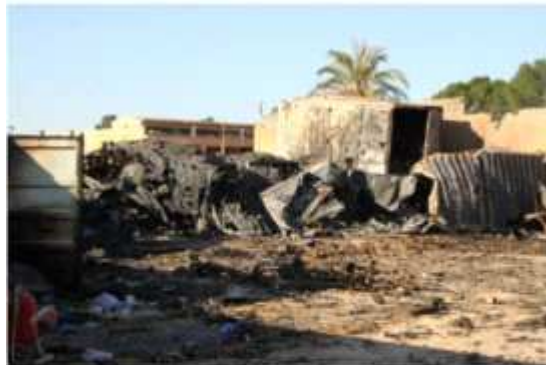
K73 03/03/12 - 09:22
View through the hole in the wall towards the destroyed container area. This is the final picture found on the SD Card.

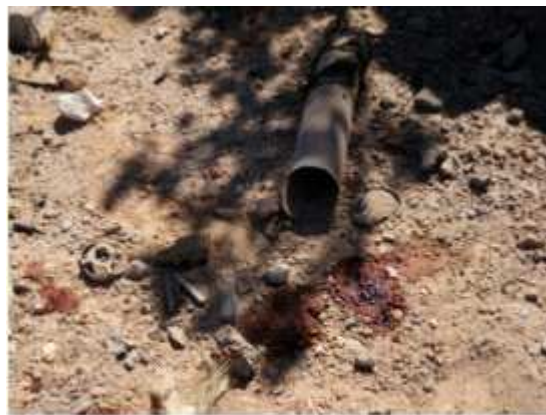
S10 03/03/12
Site of the accident with Leatherman tool and remains of detonated Type 84 mines.

[The investigators noted that the Leatherman was with the bloodstained remains of the detonated mines but did not mention it again.]

2) The investigators ignored the fact that the Victim of this accident had his leatherman multi-tool at the time. It appears in photographs amid the device debris, stained by blood, but the implication that it was in use at the time was not even considered in the report.
